Architectural Conservation Assessment  
For the Bradley Law Office  
Westminster, Vermont

Douglas Terpstra  
10/21/98

# Bradley Law Office Westminster, Vt.

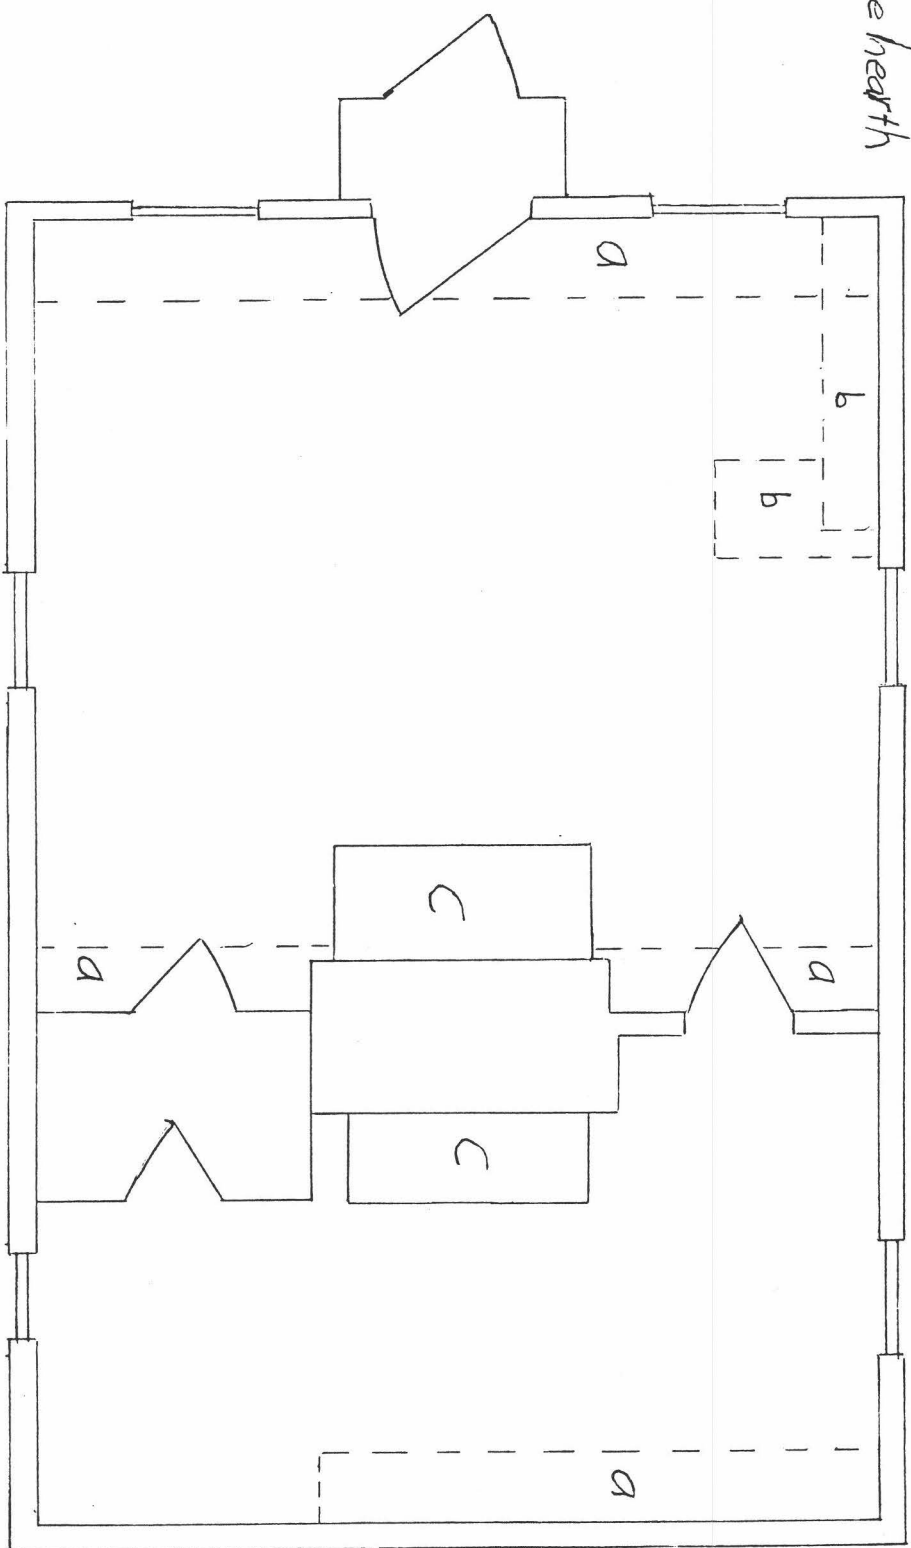
- a shelf
- b bookcase
- c fireplace hearth

1/4 inch = 1 foot

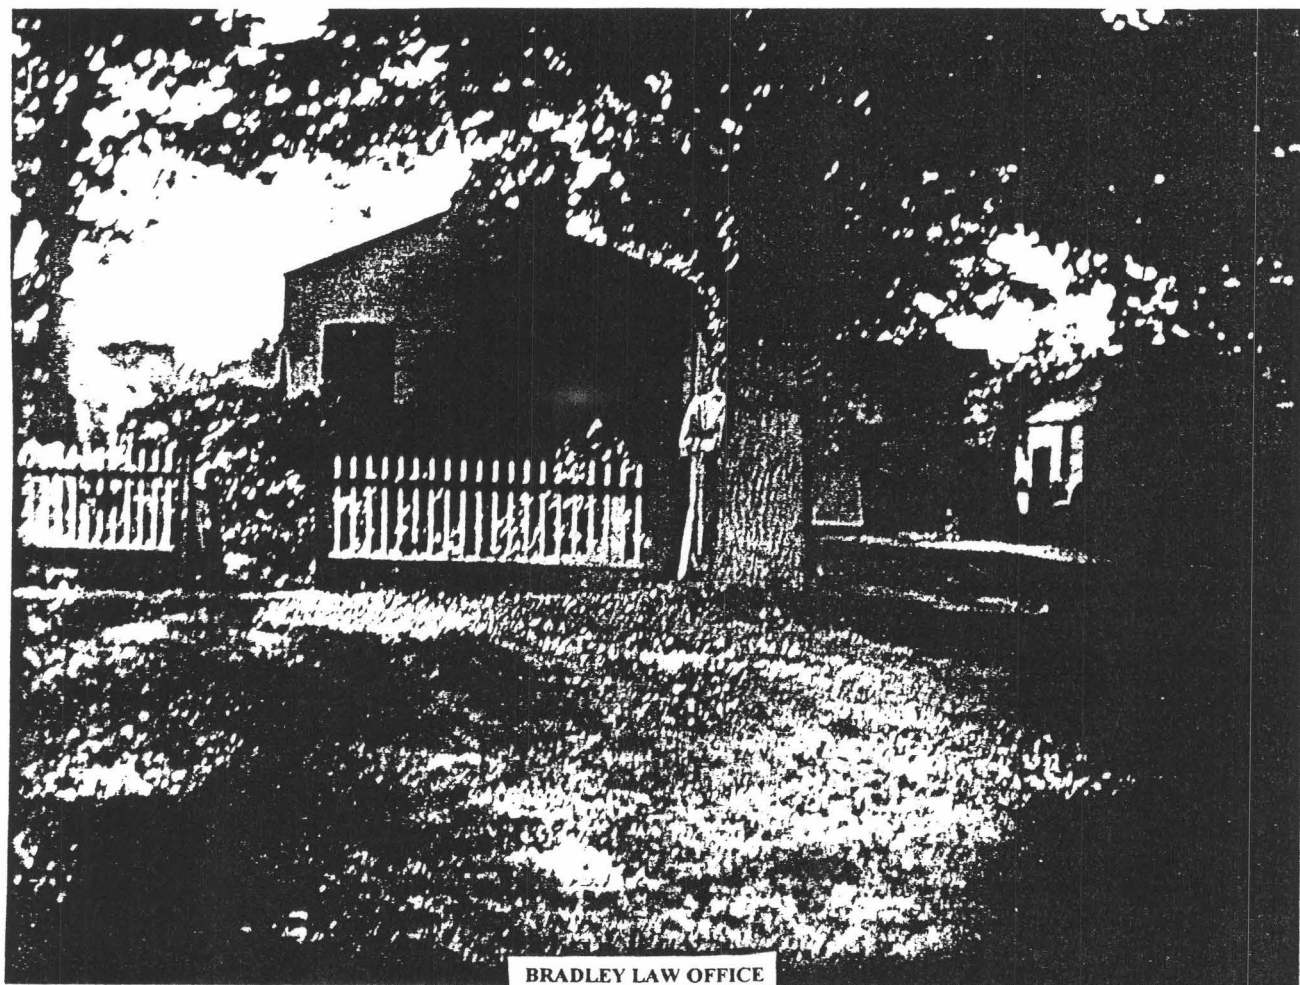
BRADLEY LAW OFFICE

Bradley Law Office, early twentieth century  
(Westminster Historical Society)

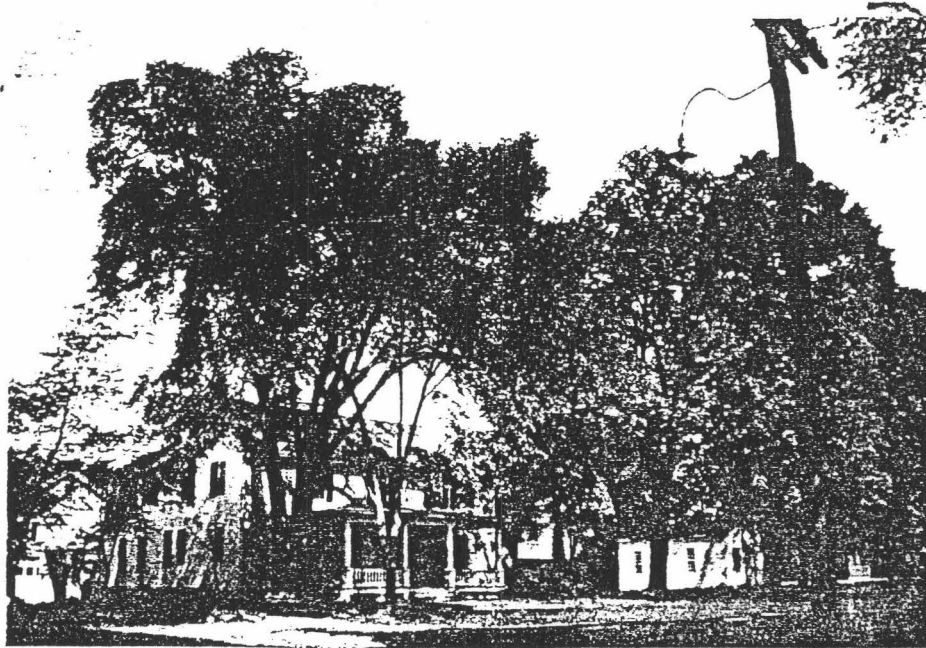
Bradley Law Office, c.1912  
(postcard, Special Collections Department, Bailey-Howe Library, UVM)

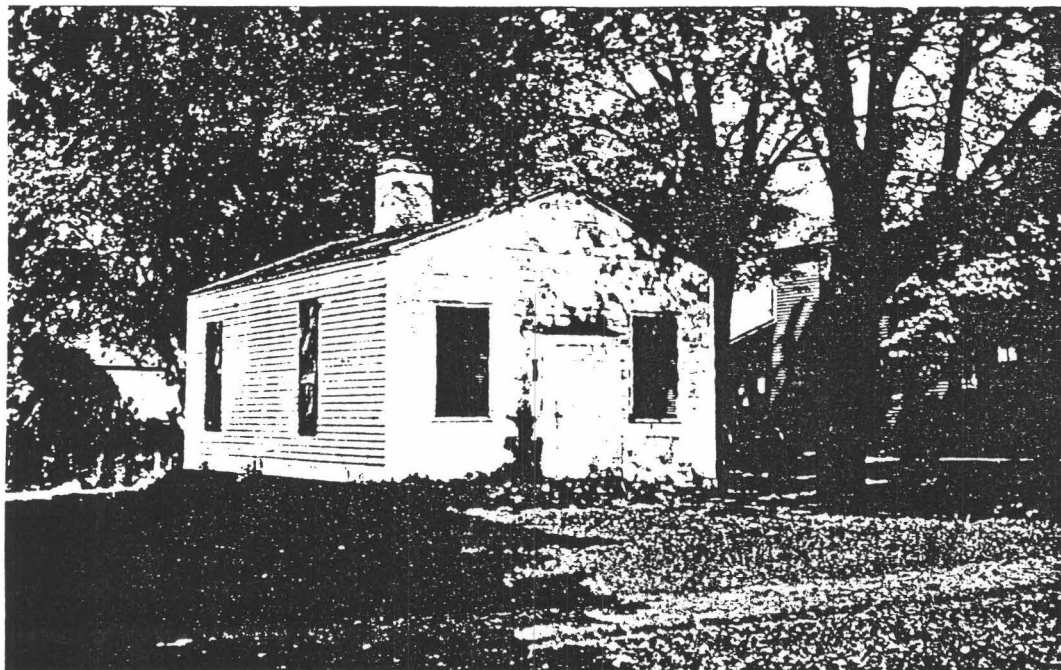
Law Office of William Czar Bradley, Westminster, Vt.

Bradley Law Office, c.1925  
(*Willard-Bradley Memoirs*, p. 51)
